# REPORT ON THE CONDITION OF PHYSICAL ELEMENTS OF TRANSMISSION AND DISTRIBUTION SYSTEMS

CASE 12-E-0201

OCTOBER 1, 2017

# 2017 NY Asset Condition Report

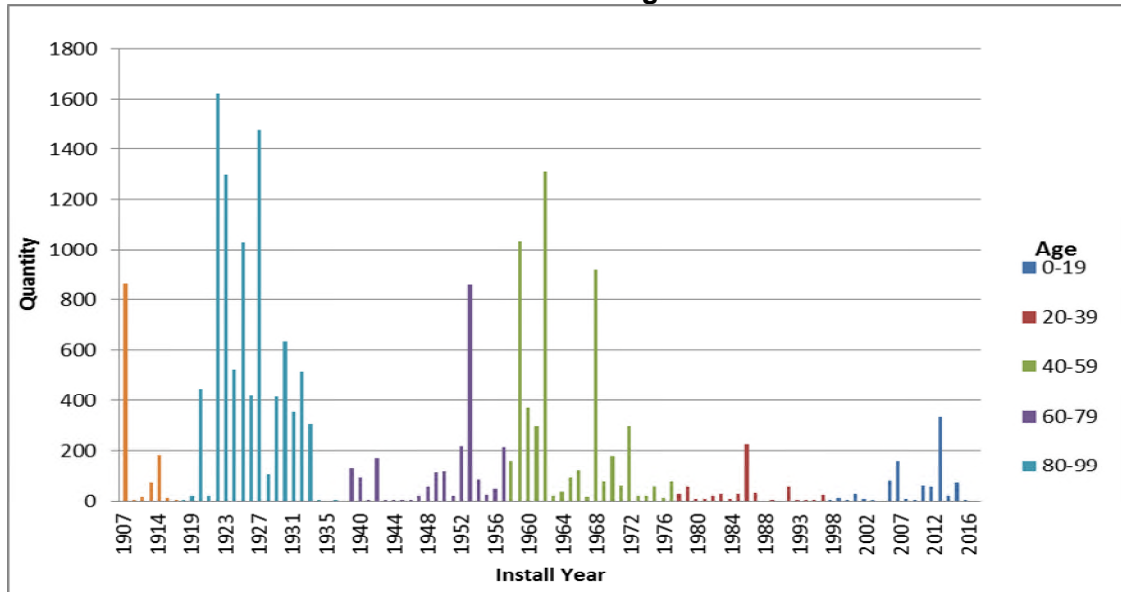
**Figure 2A-6  
NY Steel Structure Age Profile**

The age distribution of the Company's steel transmission structures is given in Figure 2A-6, color-coded to show ages of steel structures in 20-year increments. The average age of these assets is 74 years old.

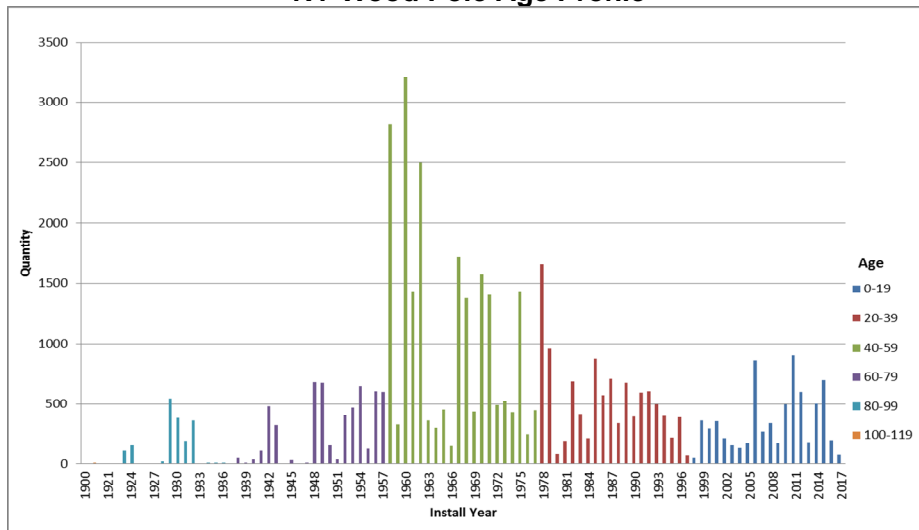
**Figure 2A-9**  
**NY Wood Pole Age Profile**

The age profile of the Company's wooden transmission poles is provided in Figure 2A-9. The average age of the Company's wooden transmission poles is 44 years.

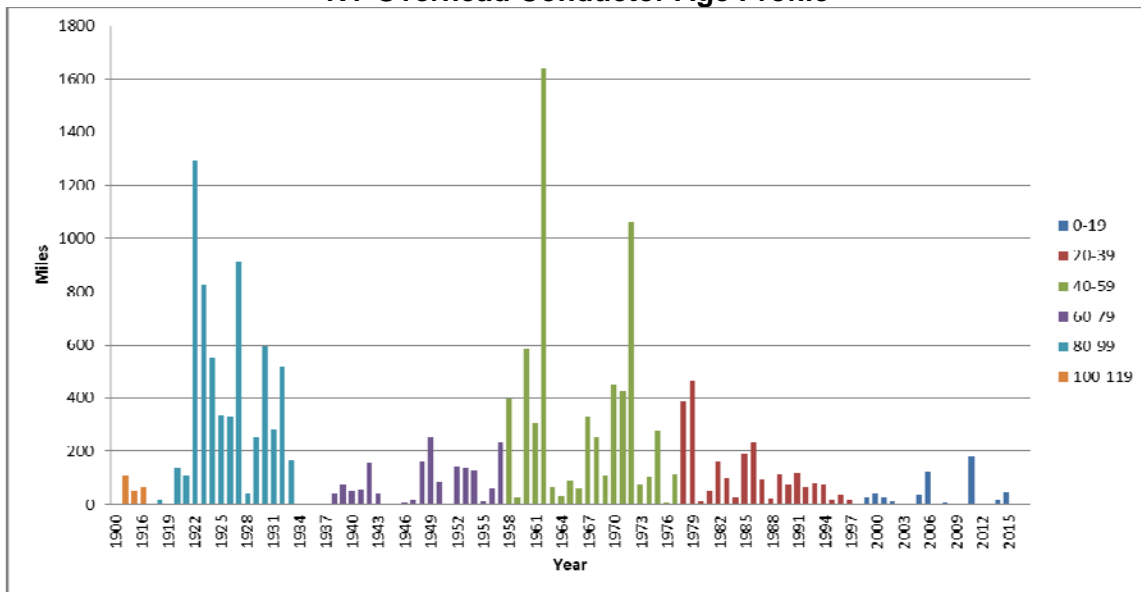
**Figure 2A-13**  
**NY Overhead Conductor Age Profile**

Figure 2A-13 shows the age profile of overhead conductors in the service territory, color coded to show ages of conductor in 20-year increments. Many miles of conductors are over 70 years old (installed in 1947 or earlier) with the average age of transmission overhead conductor 64 years<sup>4</sup>. The 115kV network is by far the oldest, with the oldest circuits being over 100 years old.

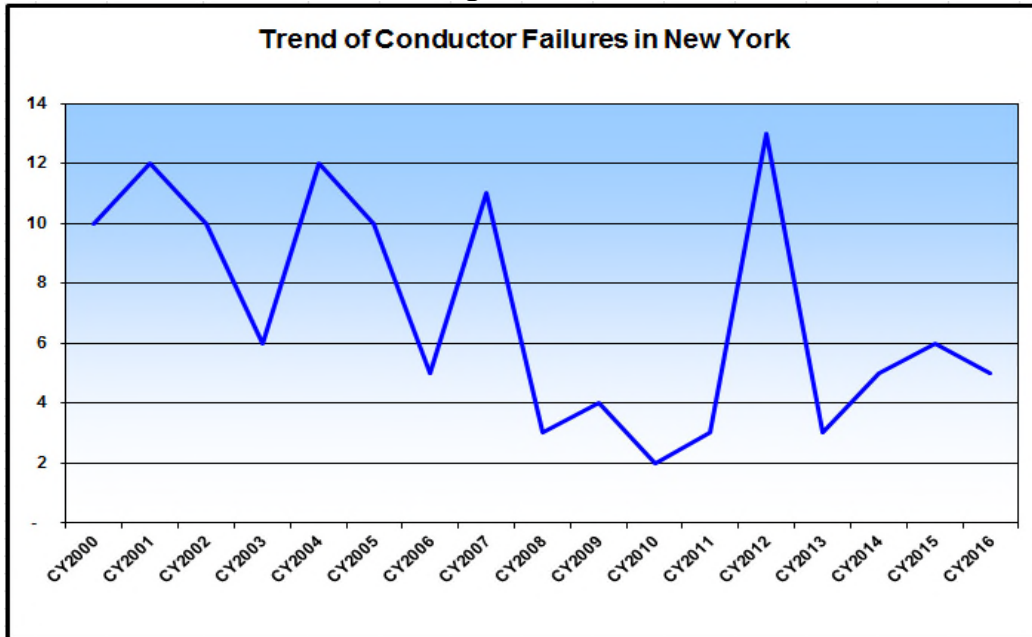
Figure 2A-14

Conductor failures from calendar year 2000 to 2017 (Figure 2A-14) show appreciable annual variability. Failures reflect a general downward trend since 2001, albeit with a spike in 2012.

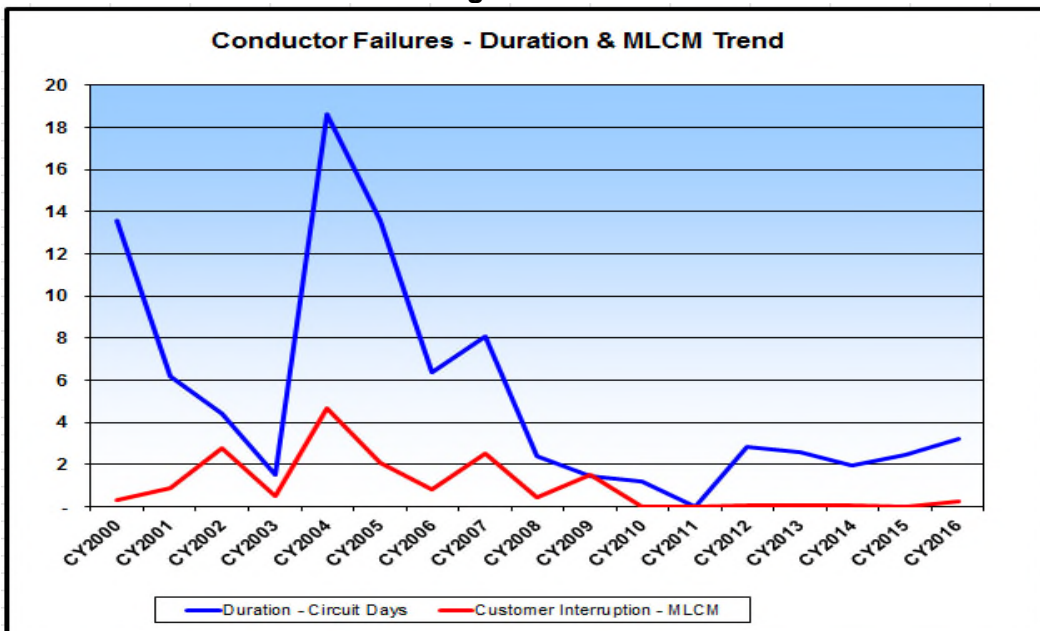
The total outage duration due to conductor failures shown in Figure 2A-15 shows a small increase in duration from 2011 to 2016, but still an overall continued downward trend in customer interruptions since 2004.

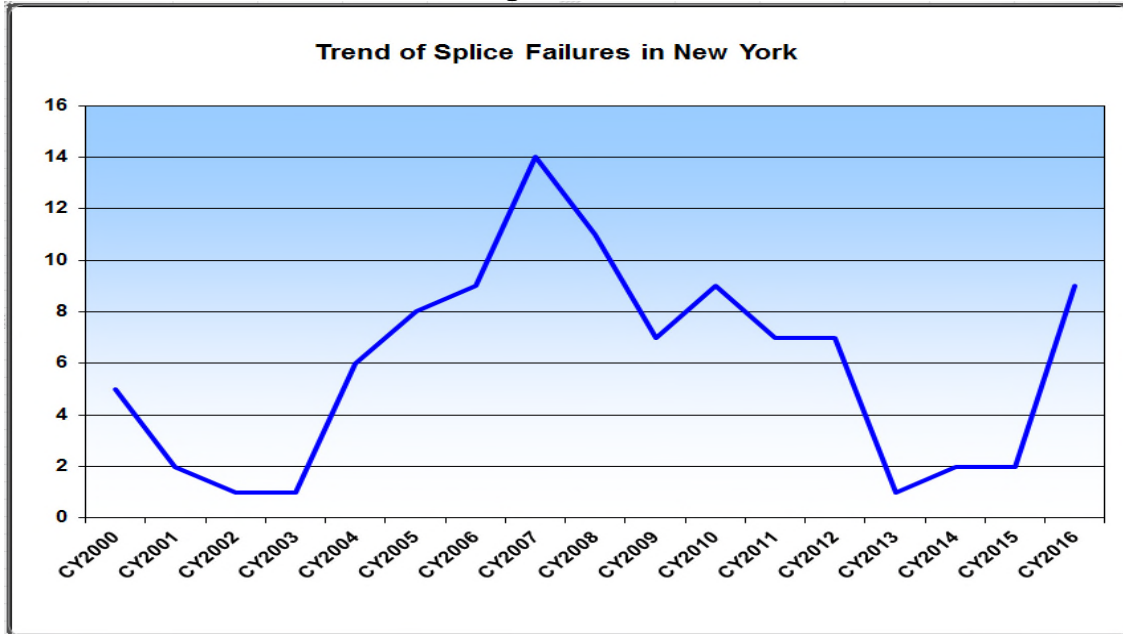
Figure 2A-17 below shows that splice failures on transmission lines spiked upward from 2015 to 2016. This increase is due to seven (7) splice failures on the Huntley-Lockport 37 115kV line in the past two years at the leading edge of splices on the 556.5 AAC

portion of the line. An overhead line refurbishment project for the lines is now in Step 0 (conceptual engineering) which includes reconductoring the six mile 556.5 AAC section of the lines to remove all the remaining splices.

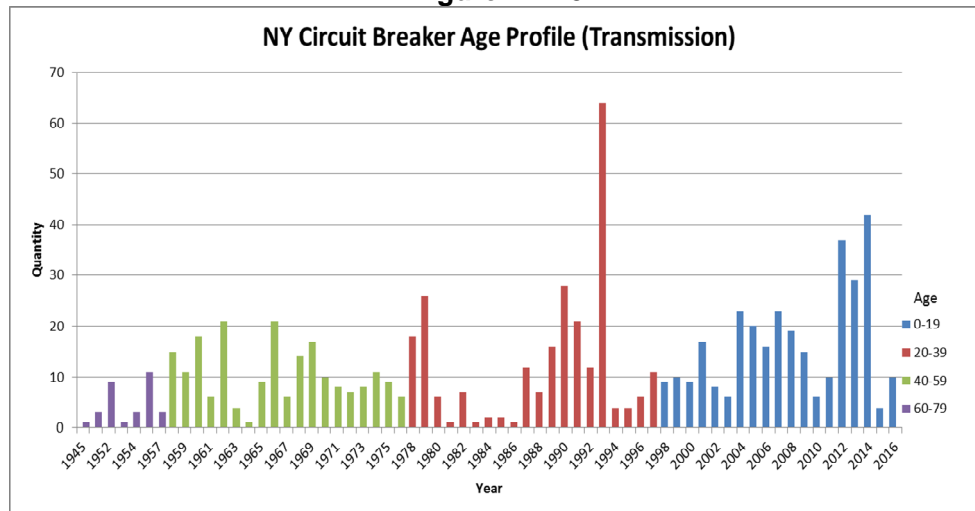
**Figure 2A-25**

An age profile is provided in Figure 2A-25.

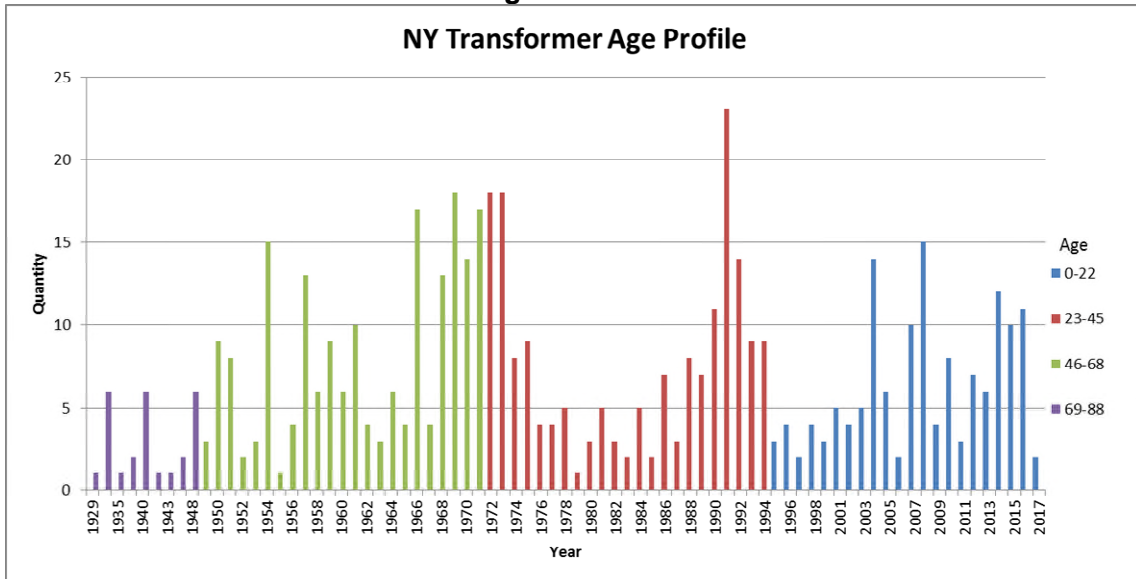
Figure 2A-29

The transmission system has a transformer population of 533 units of various manufacture, type, and power rating at primary voltages greater than 69kV. An age profile is provided in Figure 2A-29, color coded to show ages of transformers in 20-year increments. There are currently thirty-one (31) system spares for the transmission transformer fleet.

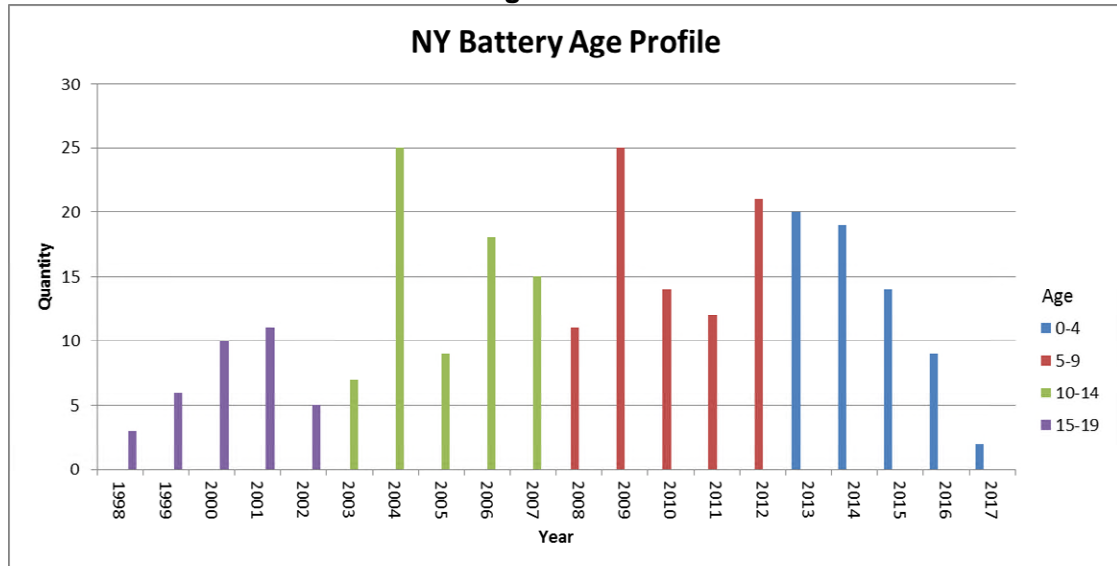
Figure 2A-33

Battery and charger systems provide power to operate substation relay and control systems which allow station breakers to operate as designed.

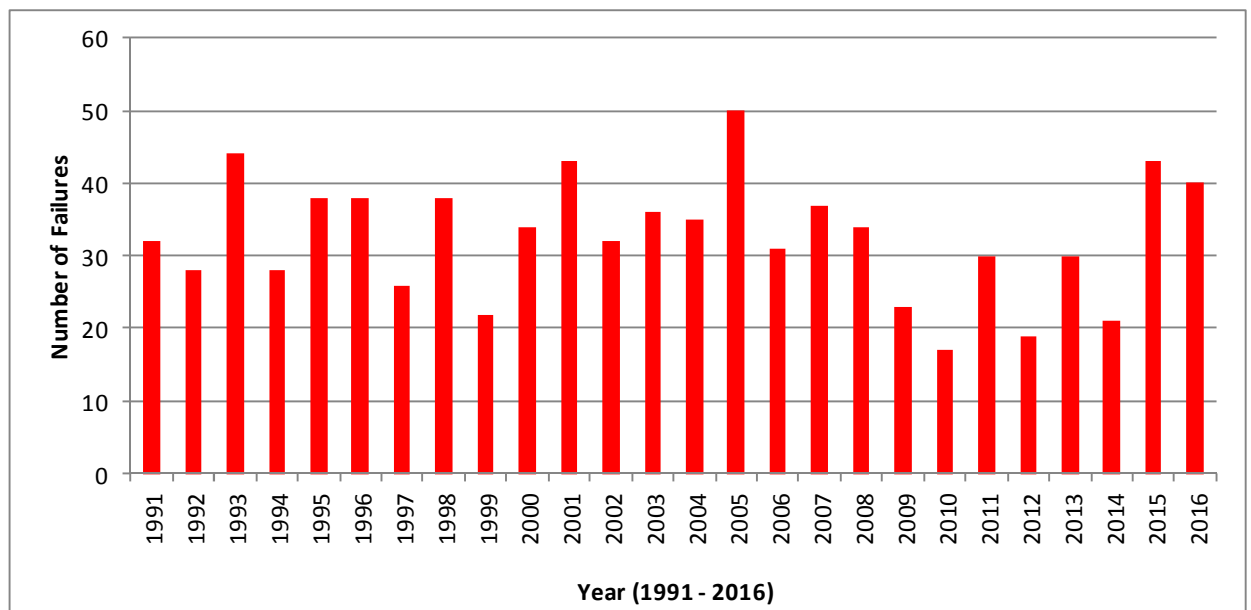
**Figure 2B-8: Buffalo 23kV Sub-T Cable Failures from 1991-2016**

Of particular concern is the sub-transmission cable system in the Buffalo area. There are approximately 433 miles of cable that supply the 23-4kV Buffalo distribution stations, LVAC network and customer owned stations. Numerous sections of the 23kV underground cables have been in service for over 80 years. See Figure 2B-8 for a graphical view of the Buffalo 23kV Sub-T cable failure data. A cable replacement program is being implemented to evaluate cables and assign priority levels to those in most urgent need of replacement. Replacement of the cables will improve reliability by reducing accumulating annual repair costs, customer outages and alleviate any thermal contingency concerns. Additional review will be conducted to develop a proactive plan for replacement of the remaining cables over a 15+ year time frame.

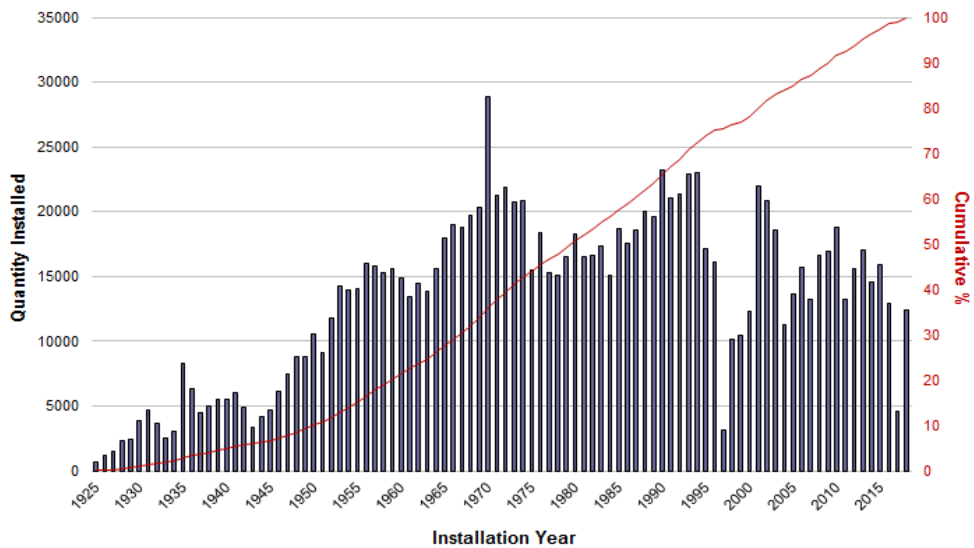
**Figure 2C-2  
Age Profile of Distribution Poles<sup>4</sup>**

Installation Year of Distribution Poles

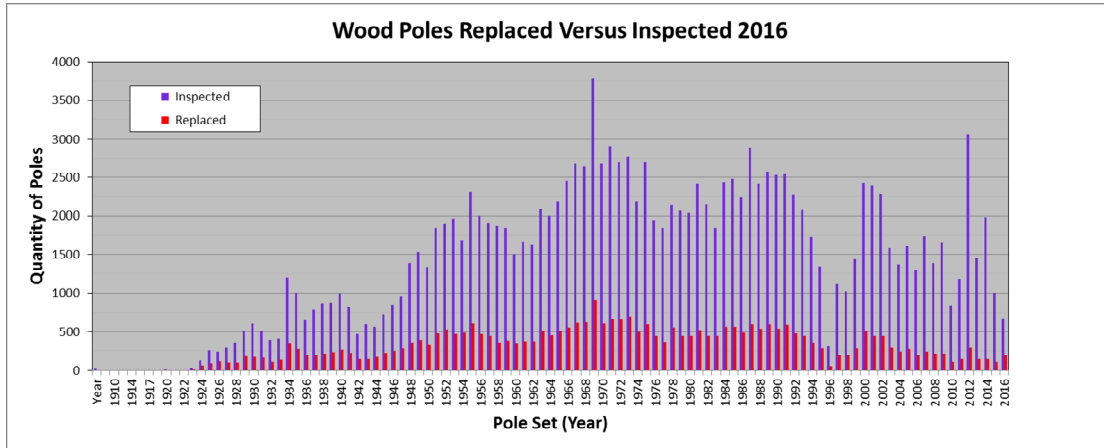
**Figure 2C-4  
Install Year Profiles of Poles Inspected Versus Replacement Candidates**

<sup>6</sup> The following asset condition codes were considered as most likely resulting in pole replacement: 110 - Broken/Severely Damaged, 111 - Visual Rotting Ground Line, 113 - CuNap Treated, 114 - Woodpecker Holes, 116 - Visual Rotting Pole Top, 117 Leaning Pole. The poles considered candidates for replacement also had the following Priority Level codes: 1 (one week), 2 (one year), 3 (three years), P (performed during inspection), 9 (temporary repair) and 7 (emergency).

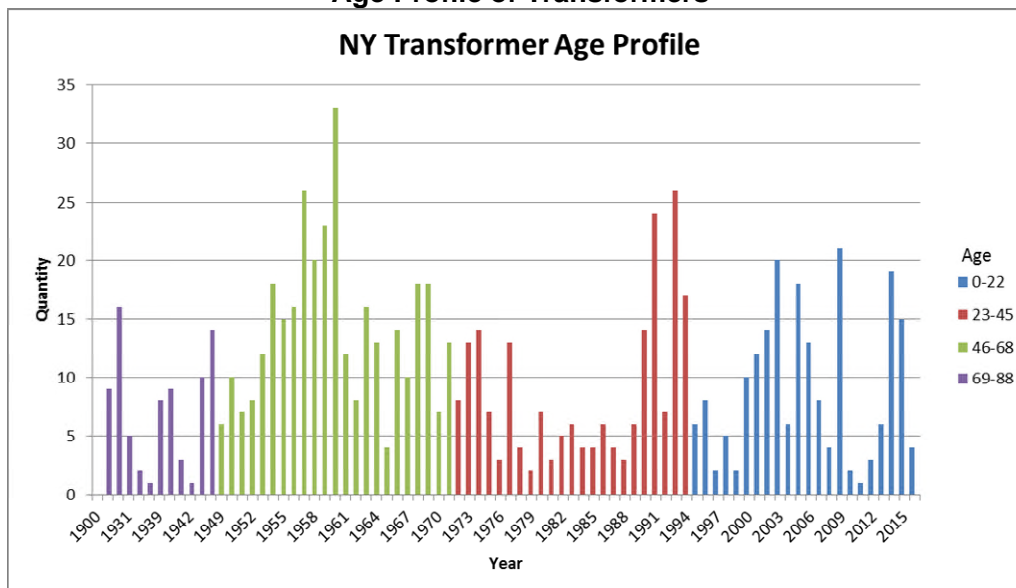
**Figure 2D-4  
Age Profile of Transformers**

The average age of the distribution power transformer population is 44 years, which is displayed in Figure 2D-4. There are 302 power transformers greater than 50 years of age based on stored nameplate data. However, 4 percent of the total population of transformers have no year of manufacture indicated in the Cascade database, which implies that there may be an additional 35 units greater than 50 years of age.

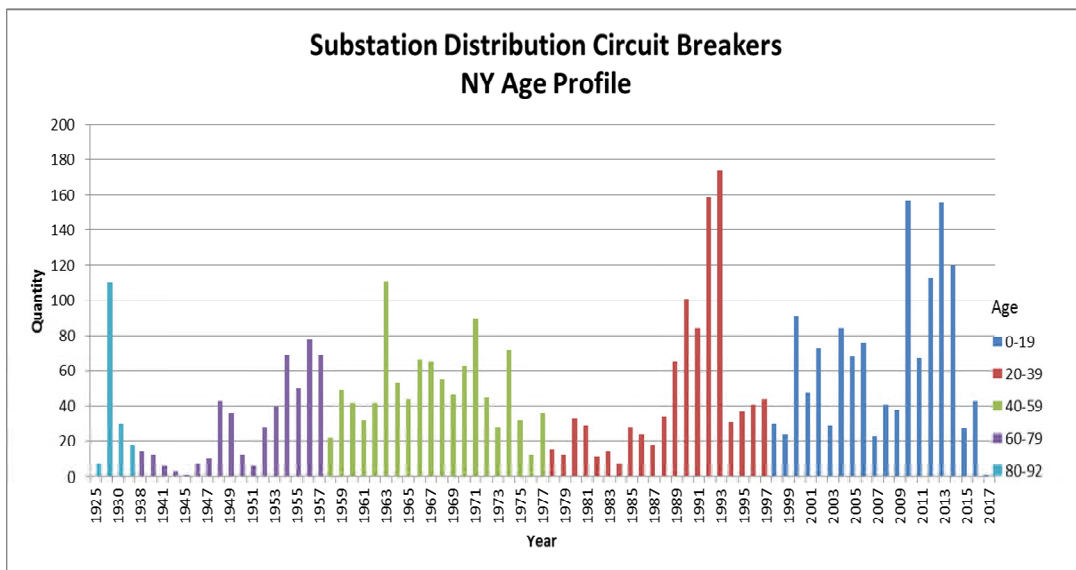
**Figure 2D-8  
Age Profile of Circuit Breakers**

National Grid has 3,922 circuit breakers and 142 spares on the distribution system, with an average age of 38 years as shown in Figure 2D-8. The substation circuit breaker population is generally sound and reliable; however, there are certain units which will be addressed as described below.

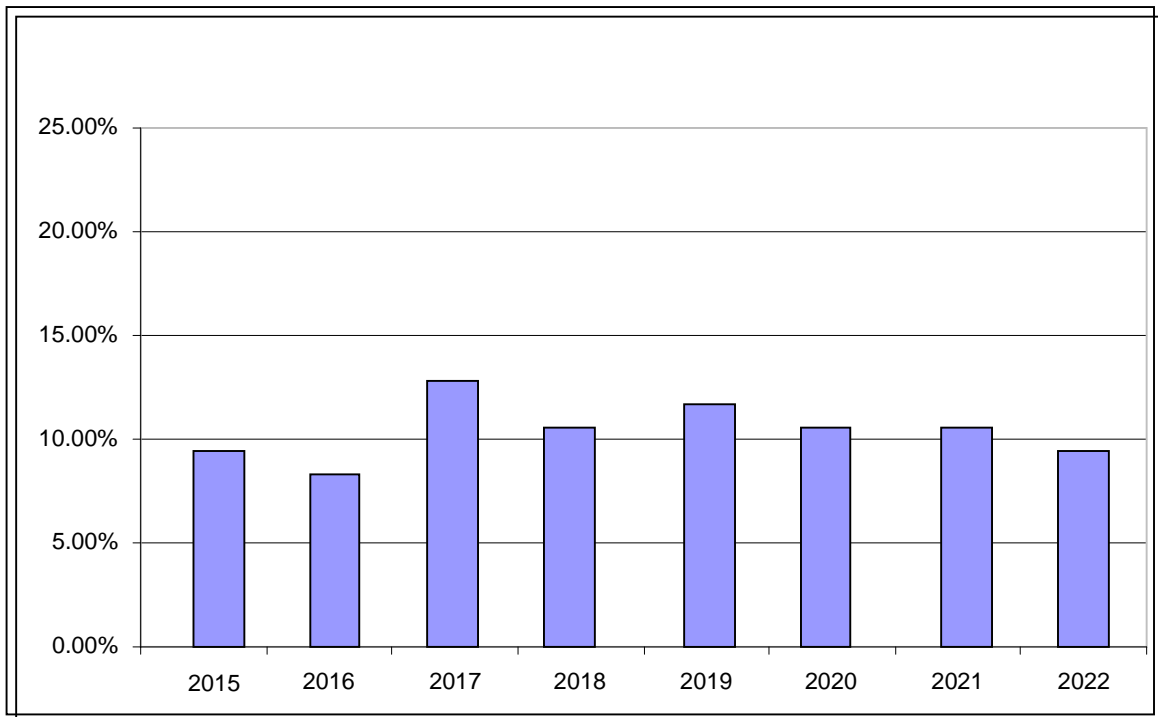
**Figure 2D-13  
Forecast Percent of relay population to be tested (by Year)**

The Company is testing between 8 and 15 percent of the relay population annually. The year on year variation occurs because of operational requirements. For example, a relay package may be tested earlier than its due date because of new installations/removals/substation rebuilds, or relay settings are changed. Each time a change is made to the relay setting, the relay is re-calibrated and the calibration date is automatically reset. When a relay is tested and fails, it will either be repaired or replaced.

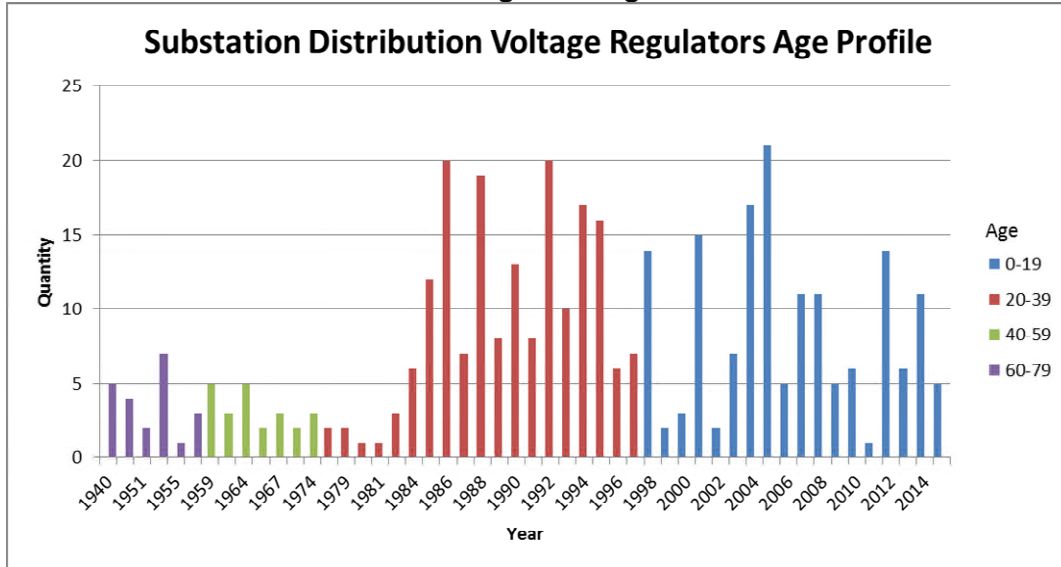
**Figure 2D-17  
New York Regulator Age Profile**

Regulators and reactors provide voltage control and power flow management capability. There are approximately 516 regulators in operation, and 14 spares in distribution substations. The average age of the operating regulator population is 24 years, however 34% do not have age data, and therefore the average age may be older. The regulator age profile is shown in Figure 2D-17 below.
